Opera Assessment Report Revision 2

Independent Assessment of Eskom's Operational Situation

August 2023

Client:	National Treasury of South Africa	
Project No:	NT015/2022	
Report Title:	Opera Assessment Report – Revision 1	
Report No:	2 NT_Eskom	
Main Authors:	Bartosz Zajda (Dornier) Manswet Banka (Dornier) Klaus Bransch (Dornier) Vladan Dokic (Dornier) Pieter Janse van Rensburg (Dornier) Dr. Thomas von Schieszl (Dornier) Jörg-Schulte Trux (KWS) Ralf Wiescher (KWS) Rainer Zobel (KWS) Axel Meschbiz (RWE) Petros Terzis (RWE)	Volkmar Bobon (STEAG) Dietmar Breuer (STEAG) Dr. Ruth Egyptien (STEAG) Werner Renk (STEAG) Sener Günes (vgbe) Bernhard Michels (vgbe) Dr. Mark Newby (vgbe) Dr. Claudia Stockheim (vgbe) Dr. Oliver Then (vgbe) Dr. Christian Ullrich (vgbe) Dr. Claudia Weise (vgbe)
Date of Issue:	August 2023

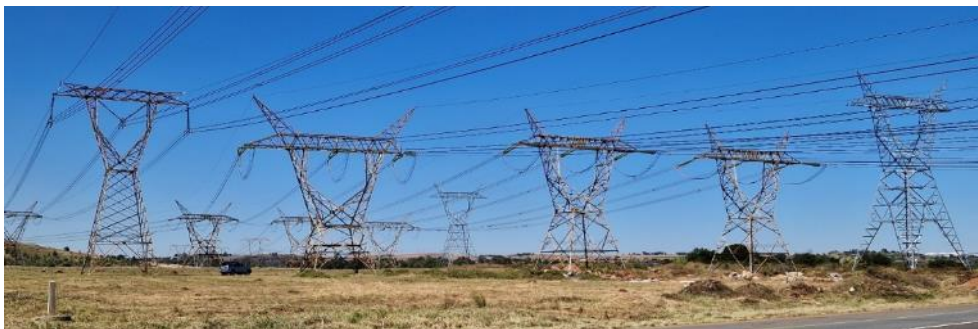
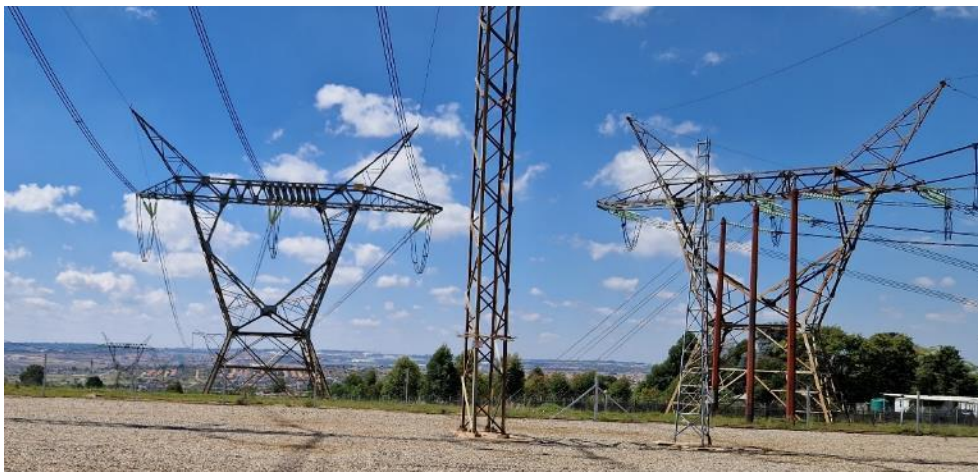
Both the inspected line section with 5 parallel 400 kV OHL (see Figure 246) and the OHL connected to the inspected substations (see Figure 247) were in a very good state of maintenance. The wear and tear of the steel structures was mostly age-related, but the insulating chains were in very good condition everywhere. Defective glass caps were not found on any overhead line. This good condition was also visible on other OHLs in the transmission system during trips. This is the result of good maintenance. All lines are flown over on a regular basis for inspection. Any defects found are eliminated at short notice. Eskom has its own team and helicopters for flying the lines. This ensures that access to that team is always available and that the inspections are carried out to a high standard. Although a large number of the overhead lines have been in operation for many years, the good maintenance of the overhead lines ensures that they are in good condition, which in turn ensures a high level of reliability and availability of the OHL. Currently, several OHLs from the 1960s – with a total length of about 1300 km - are still in operation. The overall condition of the inspected OHL is rated very good, AC 1.5 (see Figure 248).

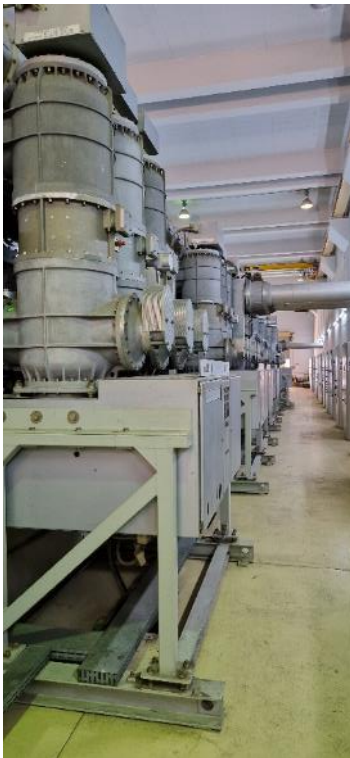
Figure 9-2: 275 kV GIS substation Craighall

Activity class of GIS classification 1,4 – Age-related wear and tear outside especially in section A 275 and 88 kV due to the operation age, only visual inspection from outside and random inspection of the displays for monitoring the switching devices, no urgent measures required (see Figure 9-2).

- 275 kV SF₆ GIS general condition section A AC classification 2 – Age-related wear and tear, refurbishment measures are not necessary.
- 275 kV SF₆ GIS general condition section B AC classification 1 – Age-related wear and tear, refurbishment measures are not necessary.
- 88 kV SF₆ GIS general condition section A AC classification 2 – Age-related wear and tear, refurbishment measures are not necessary.
- 88 kV SF₆ GIS general condition section B AC classification 1 – Age-related wear and tear, refurbishment measures are not necessary.
- Steel constructions AC classification 1 – Age-related wear and tear, refurbishment measures are not necessary.

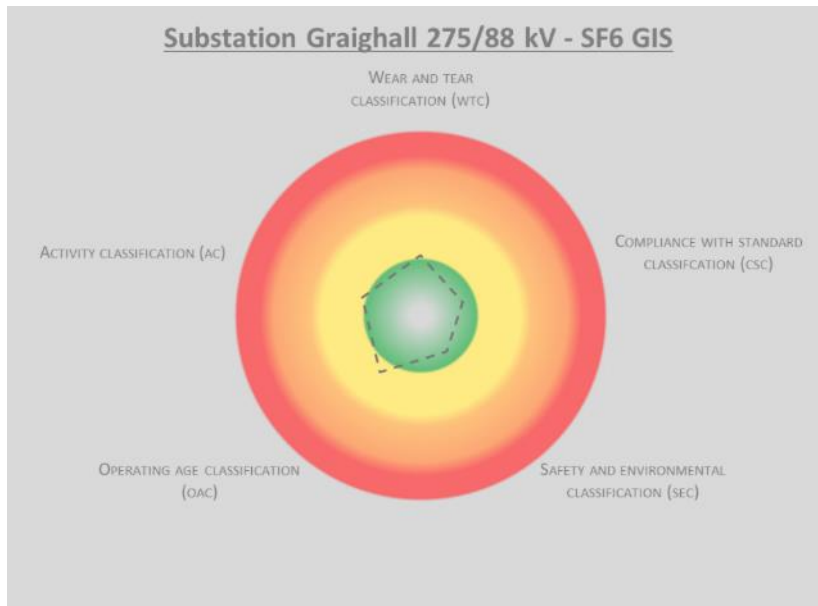
Figure 9-3: Evaluation graphic 275 and 88 kV GIS substation Craighall

Due to its age, the GIS of section A in 275 and 88 kV has small wear and tear on the outside. According to information from the substation's operating staff, all switchgear bays are well maintained and fully functional despite its high operating age. Modernisation measures can be required for the older parts of the GIS may be in the medium term (see Figure 9-3).

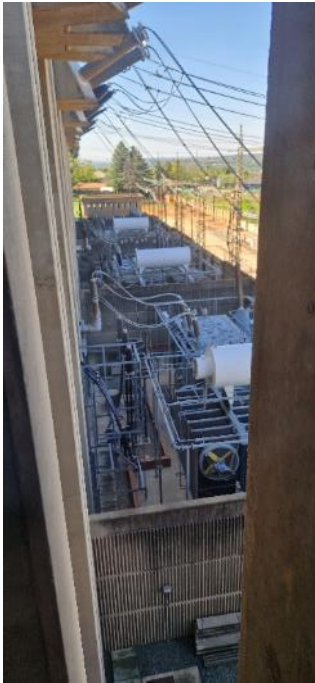
Figure 9-4: Power Transformer substation Craighall

Activity class of Power Transformers (in operation since 1977 TRFR 1 and 2, since 2010 TRFR 3) classification 1,78 – Age-related wear and tear. Transformer 1 has poor value of gas-in-oil analysis and must be observed. If the value continues to deteriorate, replacement/repair may have to be considered (see Figure 9-4)

- General impression of inspection AC classification 2 – Age-related wear and tear, refurbishment measures are not necessary.
- Gas in oil analysis (all three transformers last test of 30.12.2022, TRFR1 D poor, TRFR 2 B good, TRFR 3 A very good) AC classification 2 – Age-related wear and tear, monitoring of Gas in oil analysis results of TRFR 1.

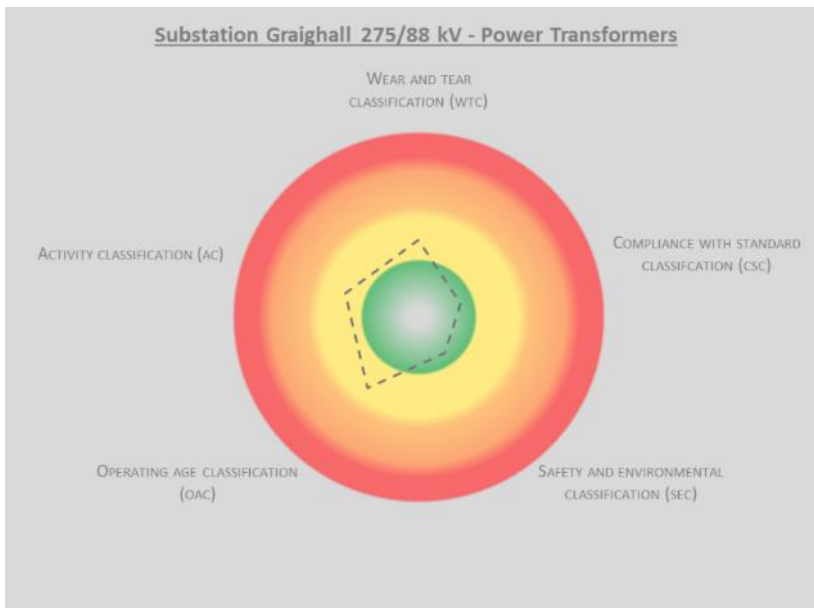
Figure 9-5: Evaluation graphic Power Transformer substation Craighall

No refurbishment measures are currently required for the transformers. The poor gas-in-oil analysis results of the transformer 1 must be monitored. Cleanliness and maintenance condition are excellent (see Figure 9-5).

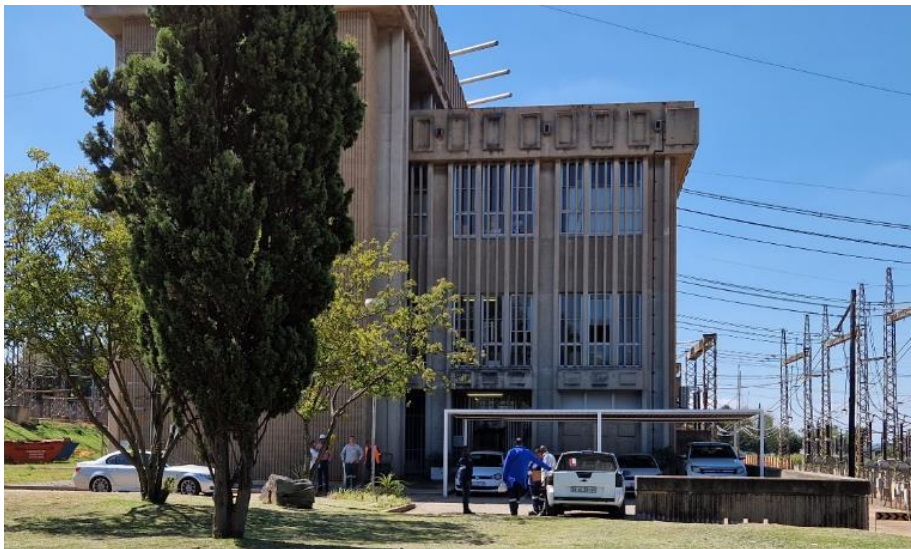
Figure 9-6: Operation Building substation Craighall

Activity class of the operation building classification 1,43 – Wear and tear due to age, no immediate measures necessary but the weathering below the roof should be investigated and could result in refurbishment measures (see Figure 9-6).

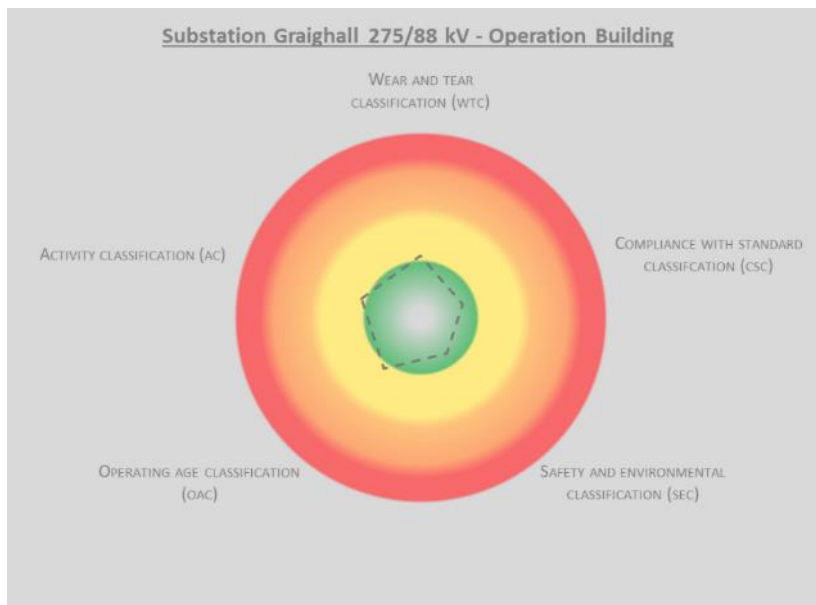
Figure 9-7: Evaluation graphic Operation Building substation Craighall

Despite its many years of use, the operation building is good condition. Cleanliness and maintenance condition are excellent (see Figure 9-7).

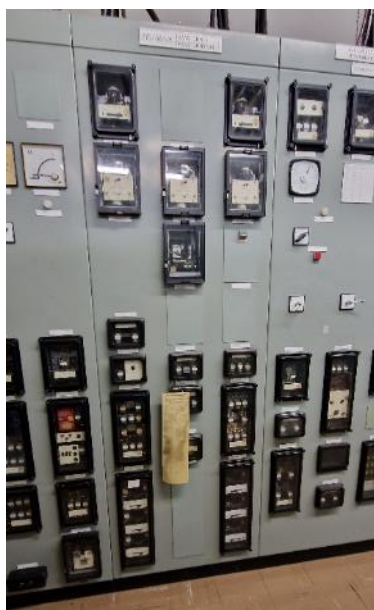
Figure 9-8: Example protection panel substation Craighall

Activity class of Secondary Technology classification 2,0 – only a few switch panels have already been renovated in terms of secondary technology. The majority is still equipped with old electromechanical protection technology. This is no longer state of the art and should be replaced in the medium term (see Figure 9-8).

- SCADA Connection to Control Centre available AC classification 2 – Partly modernised, further modernisation required in short or medium term.
- Protection relays are only a few digital AC classification 2 – Only a few relays replaced, further modernisation required in the short or medium term.

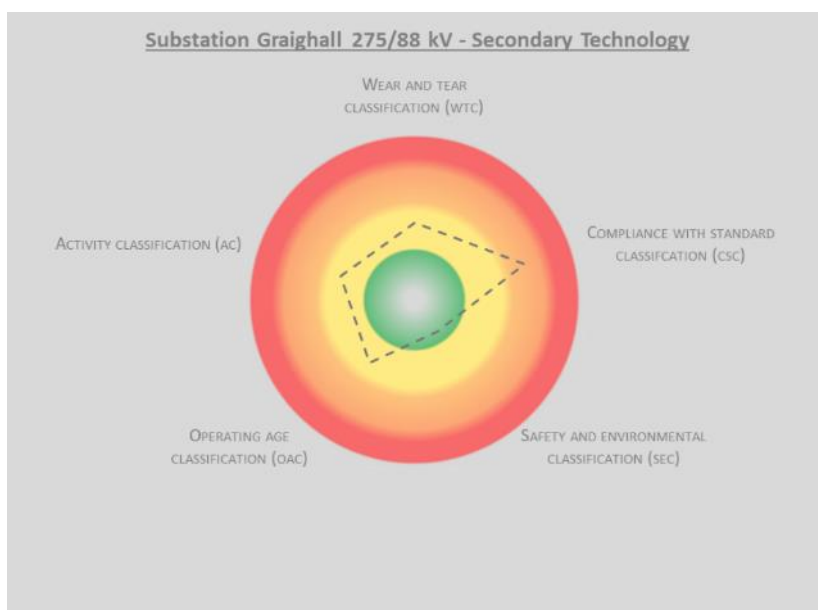
Figure 9-9: Evaluation graphic Secondary Technology substation Craighall

A high percentage of the secondary technology is still electromechanical. The devices of the secondary technology are to be replaced by modern digital equipment in short or medium term. Cleanliness and maintenance condition are excellent (see Figure 9-9).

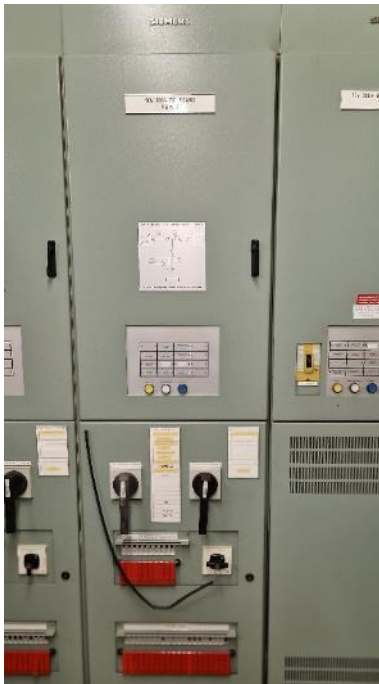
Figure 9-10: AC/DC converter substation Craighall

Activity class of AC/DC systems classification 2,0 – Age-related wear and tear (see Figure 9-10).

- AC system including auxiliary transformers and AC-distribution AC classification 2 – Age-related wear and tear, no immediate measures required.
- DC-distribution AC classification 2 – Age-related wear and tear, no immediate measures required.

- AC/DC converters AC classification 2 – Age-related wear and tear, no immediate measures required.

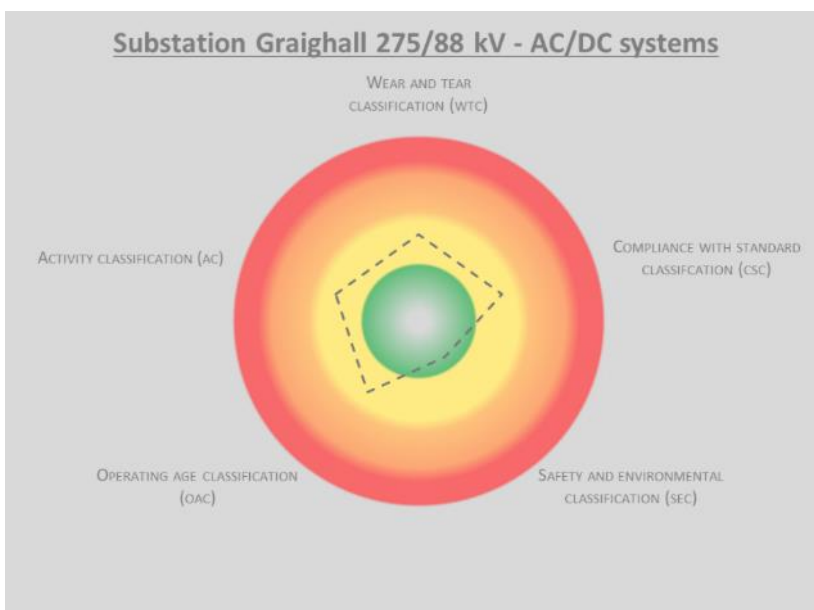
Figure 9-11: Evaluation graphic AC/DC systems substation Craighall

The AC/DC systems are old but in good condition for their operation age. Cleanliness and maintenance condition are excellent (see Figure 9-11).

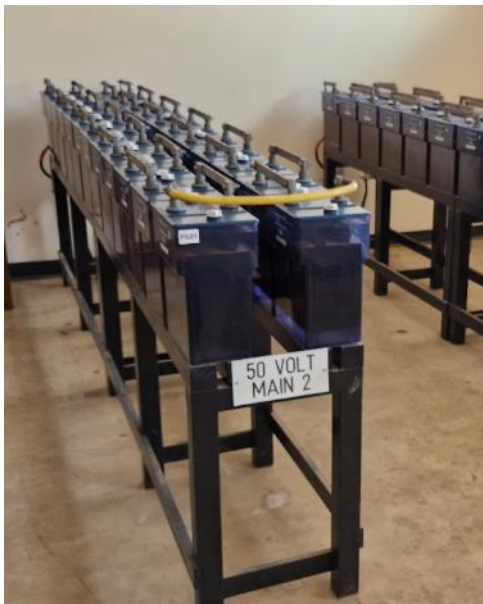
Figure 9-12: Battery systems substation Craighall

Activity class of Battery systems classification 1 – condition without findings, no measures necessary (see Figure 9-12).

- 220 V Batteries AC classification 1 – condition without findings.
- 50 V Batteries AC classification 1 – condition without findings.

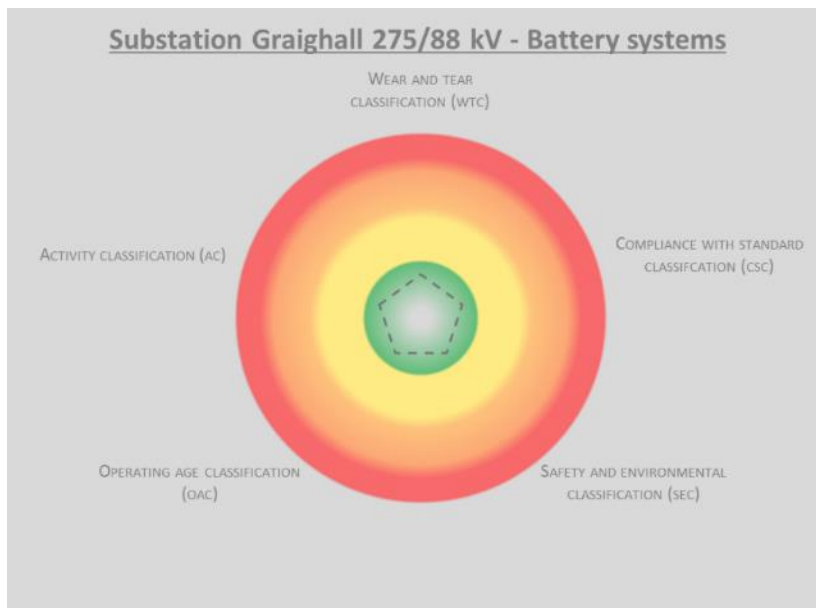
Figure 9-13: Evaluation graphic Battery systems substation Craighall

The battery systems were renewed cyclically during operation. The current status corresponds to the state of the art. Cleanliness and maintenance condition are excellent (see Figure 9-13).

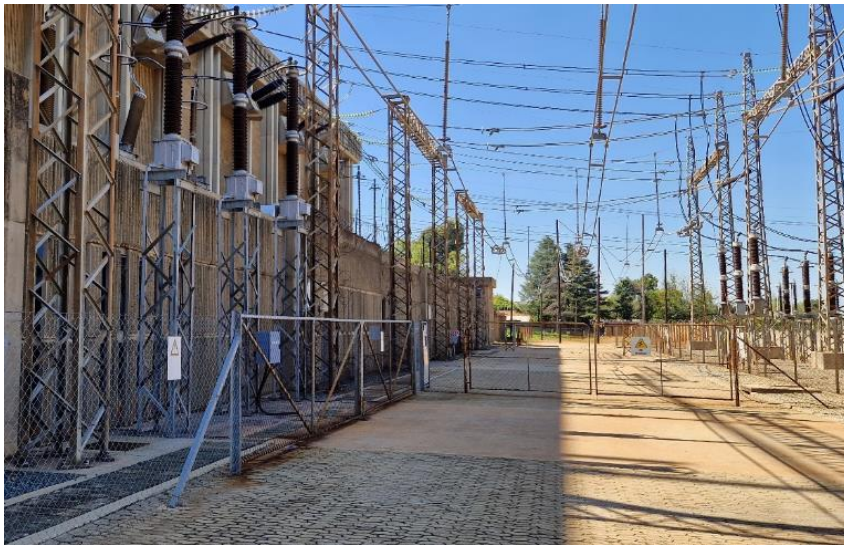
Figure 9-14: Street and fences substation Craighall

Activity class of streets, footpaths and fences classification 1,0 – Age-related wear and tear, but in a very good state of maintenance (see Figure 9-14).

- General condition AC classification 1 – Age-related wear and tear, no measures required.
- Fences and security AC classification 1 – Age-related wear and tear, no measures required.
- Dimensioning AC classification 1 – Age-related wear and tear, no measures required.

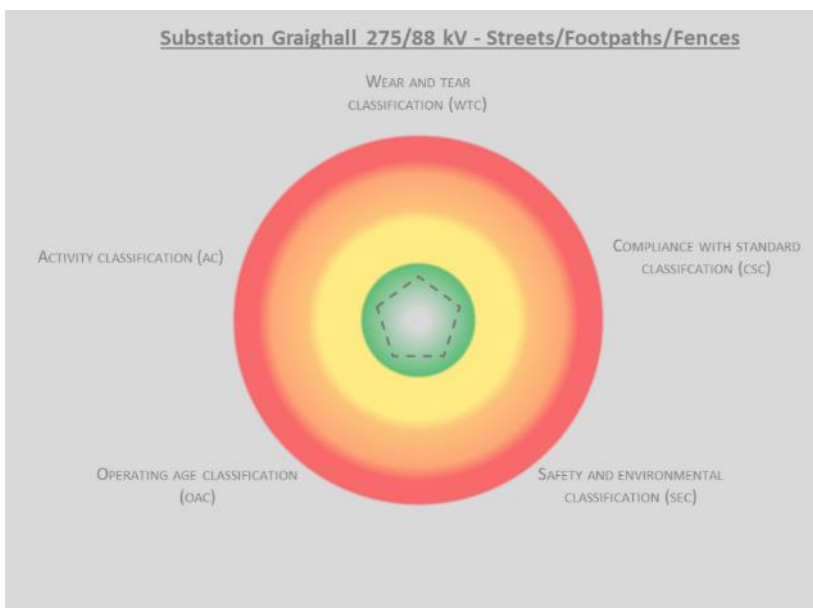
Figure 9-15: Evaluation graphic Streets/Footpaths/Fences substation Craighall

The streets, footpaths and fences are in good condition. No measures are required. Cleanliness and maintenance condition are excellent (see Figure 9-15).

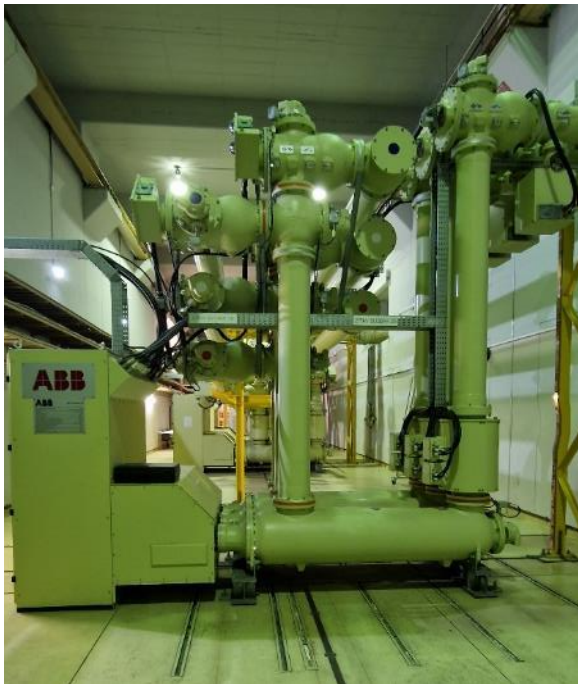
Figure 9-16: 88 kV GIS substation Craighall

The Craighall substation was commissioned in 1978 (see Figure 9-16). The GIS of the substation was extended by several switchgear bays in 2008. With this expansion, several modernization measures were implemented. However, the majority of the secondary technology is at the level of the 1978 commissioning. Due to the excellent maintenance condition of all components of the substation, it is fully functional and available with a high degree of reliability despite its high operating age. In line with the general modernization strategy for the transmission system, the Craighall substation should also be modernized in the medium term. The activity class was assessed at 1.52 (see Figure 9-17).

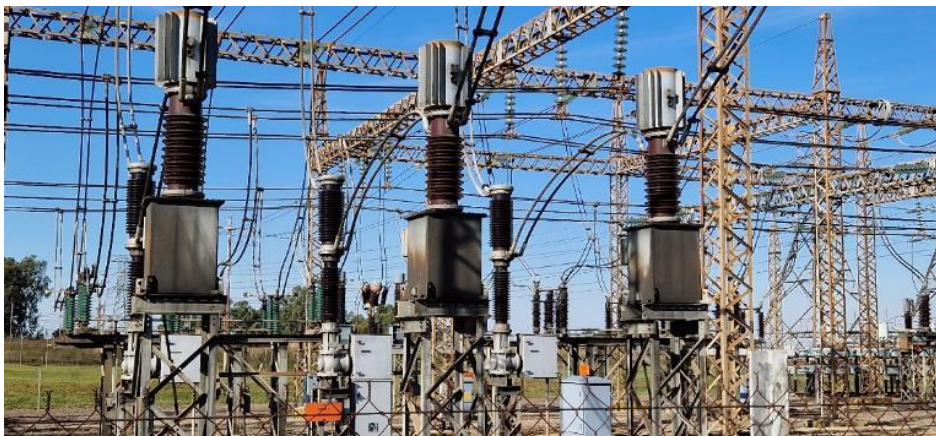
Figure 9-19: 88 kV switchgear substation Eiger

Activity class of switchgears classification 2.43 – Age-related wear and tear, little rust on steel structures, a few equipment items have been partially replaced by new equipment, no urgent measures required at the moment, but failures of equipment are to be expected due to age, a plan for modernisation should be developed and implemented in the near future (see Figure 9-19)

- Most circuit breakers are old, only few are replaced by SF₆-circuit-breakers AC classification 3 – Old low-oil circuit breakers should be replaced in the near future.

- Most disconnectors are old, only few are replaced by new one's AC classification 3 – Old disconnectors should be replaced in the near future.
- Most instrument transformers are old, only few are replaced AC classification 3 – Old instrument transformers should be replaced in the near future.

- Conductor ropes are corroded due to age. AC classification 2 – Age-related wear and tear, refurbishment measures are not necessary.
- Steel construction slight signs of rust AC classification 2 – Age-related wear and tear, refurbishment measures are not necessary.

- Basements with some wear and tear AC classification 2 – Age-related wear and tear, refurbishment measures are not necessary.
- Groundings visually inspected at random, visual signs of wear AC classification 2 – Age-related wear and tear, refurbishment measures are not necessary.

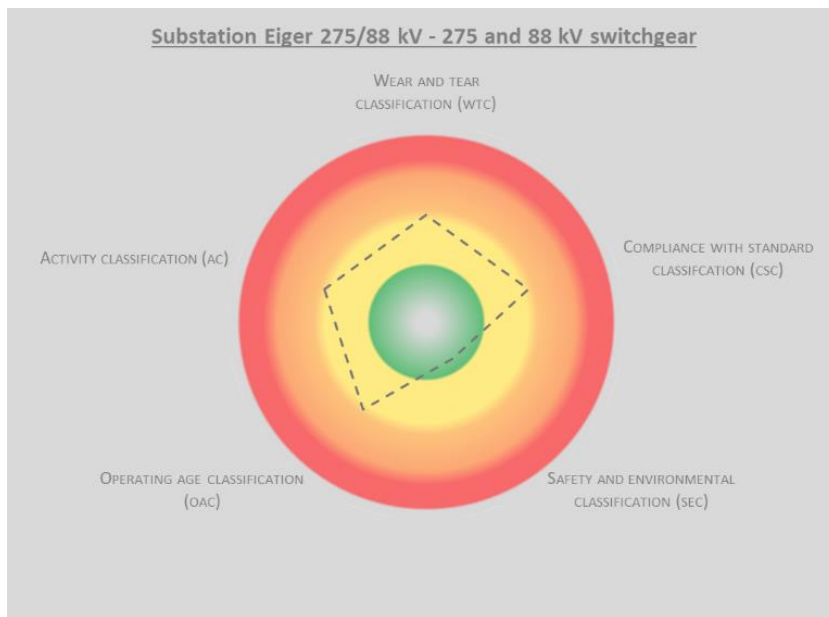
Figure 9-20: Evaluation graphic 275 and 88 kV switchgear substation Eiger

Due to operation age of 50 years, the switchgear shows wear and tear. Few major components of the switchgear were replaced by new equipment. Due to the good maintenance of the switchgear, it is fully functional despite its high operating age. Further modernisation measures are to be carried out in the near future. Much of the equipment appears to have reached the end of its service life and should be replaced as part of a basic modernisation plan for the substation (see Figure 9-20).

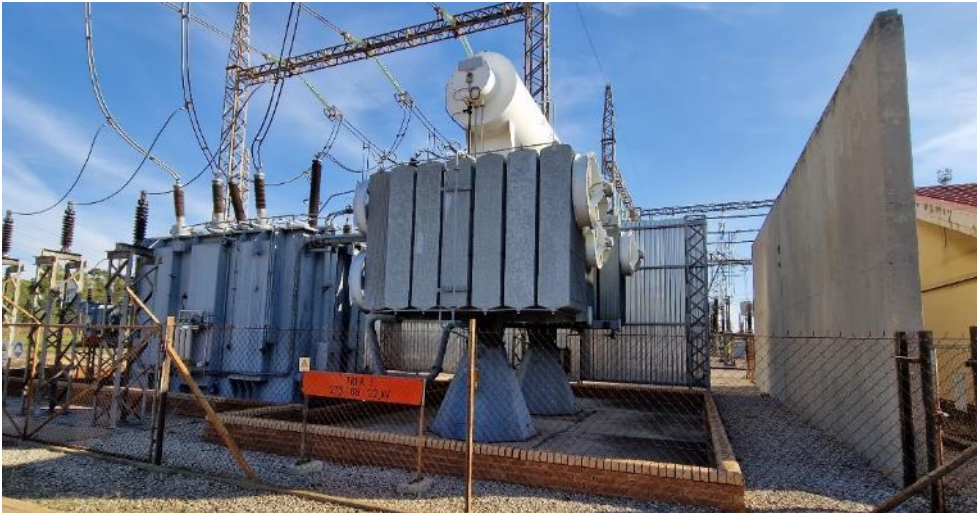
Figure 9-21: Power Transformer 3 substation Eiger

Activity class of Power Transformers (in operation between 1986 and 2013) classification 1,56 – Age-related wear and tear. The power transformers were replaced in the past (1986, 1997 and 2013). The last gas in oil analysis results were very good for all three transformers (see Figure 9-21)

- General impression of inspection AC classification 2 – Age-related wear and tear, refurbishment measures are not necessary.
- Gas in oil analysis (all three transformers last test of 07.09.2022, all results A very good) AC classification 1 – condition without findings.

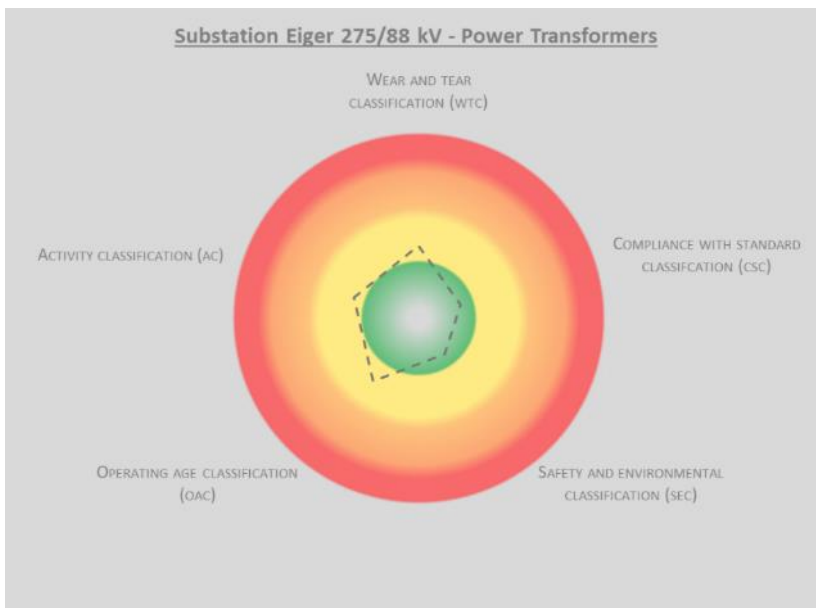
Figure 9-22: Evaluation graphic Power Transformers substation Eiger

No refurbishment measures are currently required for the transformers. Cleanliness and maintenance condition are excellent (see Figure 9-22).

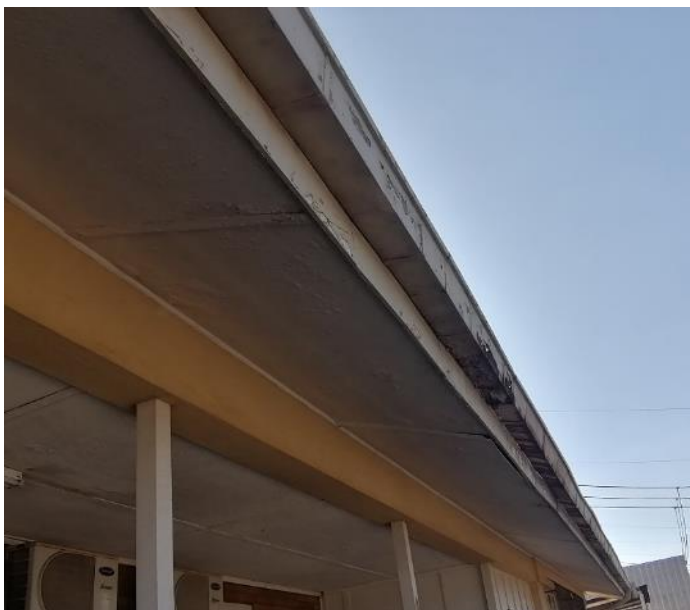
Activity class of the operation building classification 1,93 – Wear and tear due to age, no immediate measures necessary but the defective gutter should be repaired quickly. It should be assessed if further rehabilitation measures are required (see Figure 9-23).

- Outside general impression of inspection AC classification 3 – Wear and tear due to age, defect rain gutter shall be repaired quickly.

- Roof visual inspection from the ground AC classification 3 – Wear and tear due to age, Wear and tear due to age, defect rain gutter shall be repaired quickly.

Figure 9-23: Operation Building substation Eiger, small defects of the roof observed

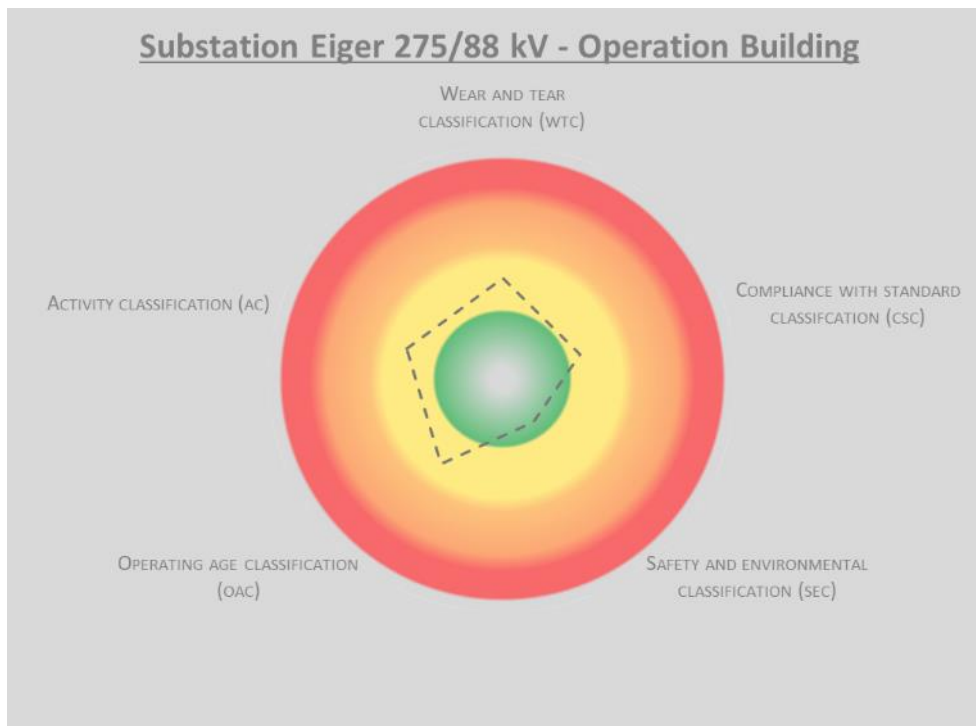
Figure 9-24: Evaluation graphic of Operation Building substation Eiger

Despite its many years of use, the operation building is general in good condition. The repair of the gutter should be done in the short term. At the same time, the water tightness of the roof should be checked and, if necessary, further renovation work should be carried out. Cleanliness and maintenance condition are excellent (see Figure 9-24).

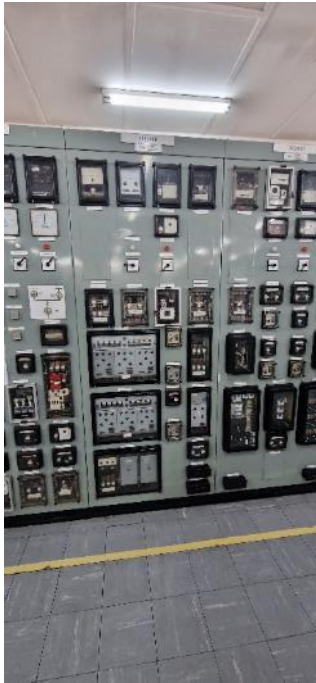
Figure 9-25: Example of control and protection panel substation Eiger

Activity class of Secondary Technology classification 3,0 – only few switch panels have already been renovated in terms of secondary technology. The majority is still equipped with old electromechanical protection technology. This is no longer state of the art and should be replaced in the medium term (see Figure 9-25).

- SCADA Connection to Control Centre available AC classification 3 – Only a few are modernised, further modernisation required in short or medium term.
- Protection relays are only a few digital AC classification 3 – Only a few relays are replaced, further modernisation required in the short or medium term.

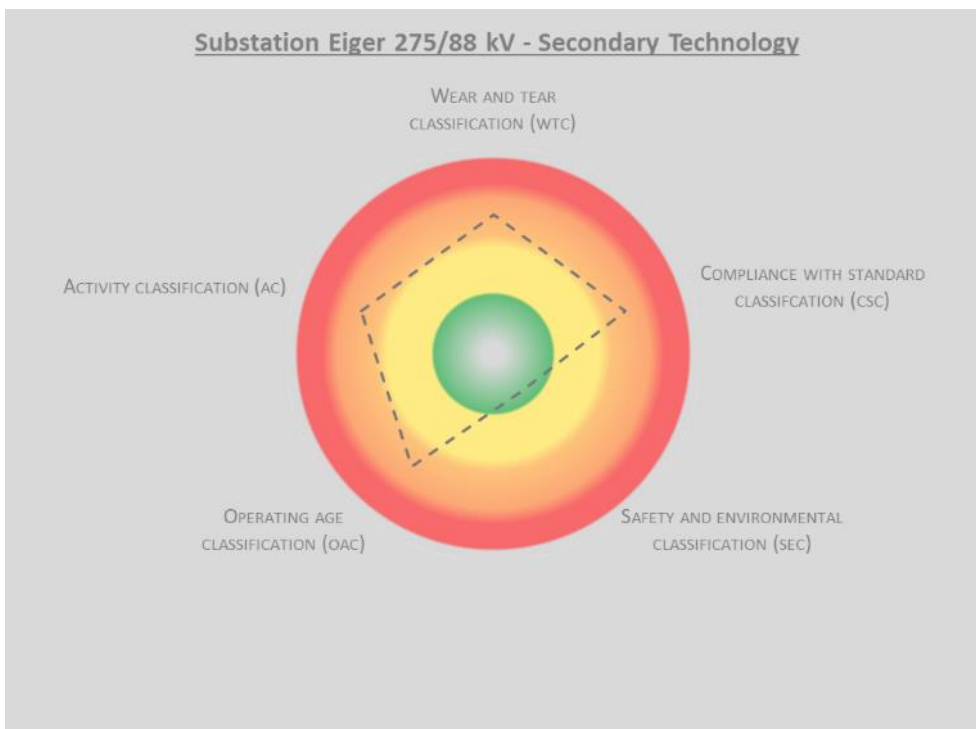
Figure 9-26: Evaluation graphic Secondary Technology substation Eiger

A high percentage of the secondary technology is still electromechanical. Only the busbar protection of 275 and 88 kV switchgear is digital technology. The electromechanical devices of the secondary technology are to be replaced by modern digital equipment in short or medium term. Cleanliness and maintenance condition are excellent (see Figure 9-26).

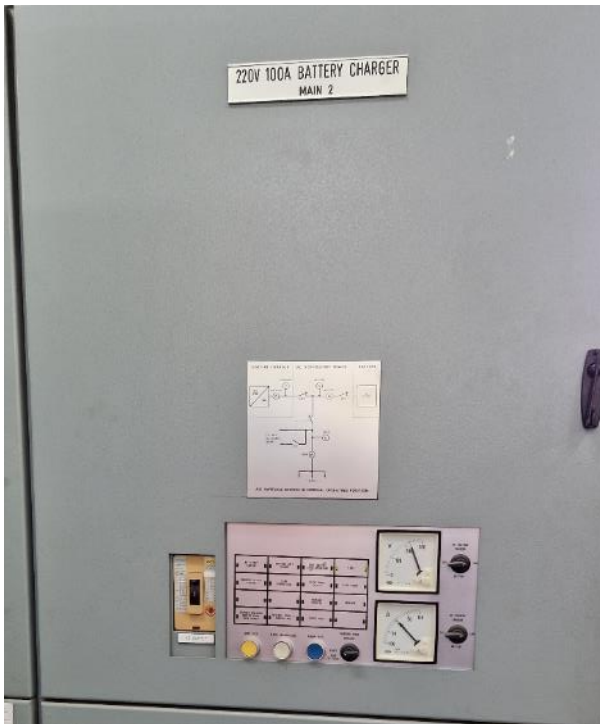
Figure 9-27: AC/DC converter substation Eiger

Activity class of AC/DC systems classification 2,0 – Age-related wear and tear (see Figure 9-27).

- AC system including auxiliary transformers and AC-distribution AC classification 2 – Age-related wear and tear, no immediate measures required.
- DC-distribution AC classification 2 – Age-related wear and tear, no immediate measures required.
- AC/DC converters AC classification 2 – Age-related wear and tear, no immediate measures required.

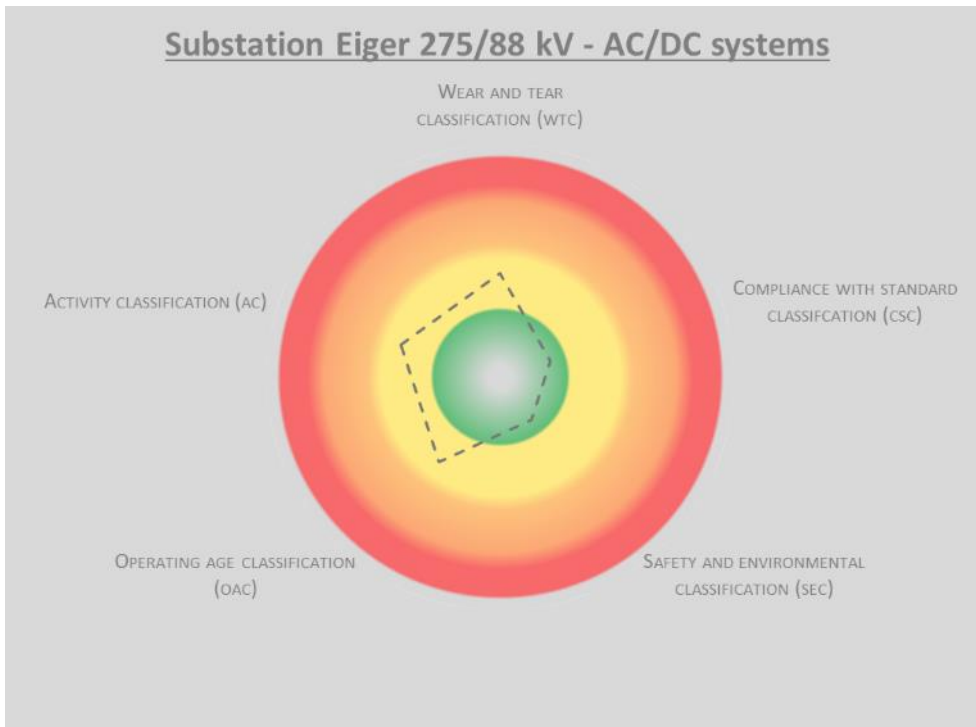
Figure 9-28: Evaluation graphic AC/DC systems substation Eiger

The AC/DC systems are old but in good condition for their operation age. Cleanliness and maintenance condition are excellent (see Figure 9-28).

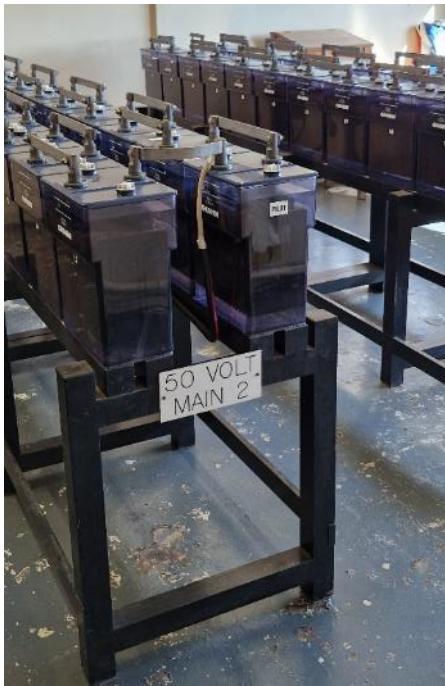
Figure 9-29: 50 V Battery substation Eiger

Activity class of Battery systems classification 1 – condition without findings, no measures necessary (see Figure 9-29).

- 220 V Batteries AC classification 1 – condition without findings.
- 50 V Batteries AC classification 1 – condition without findings.

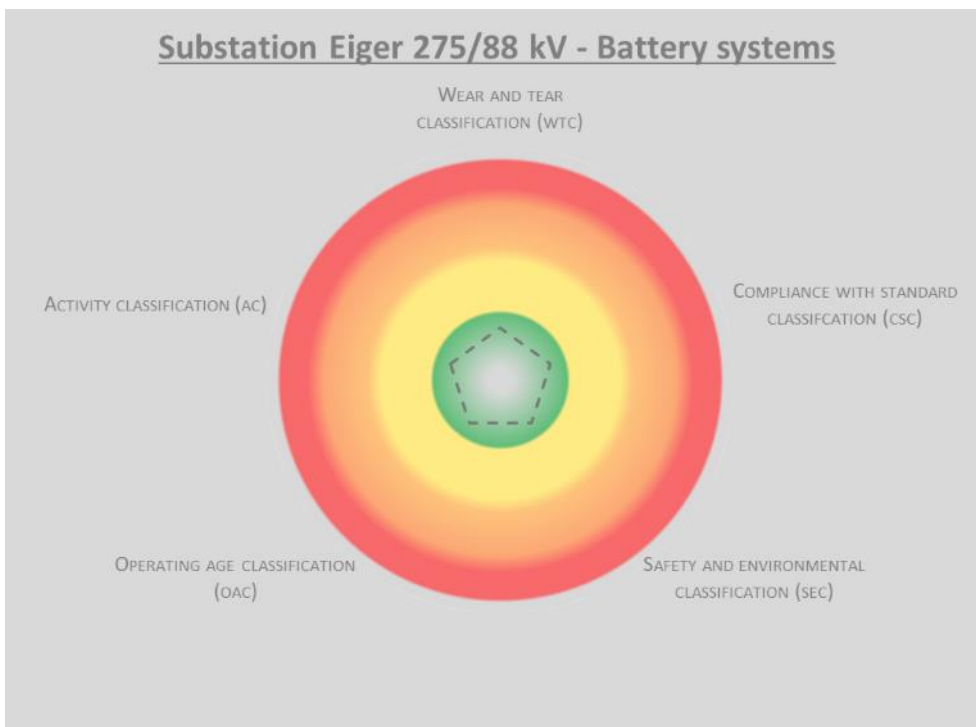
Figure 9-30: Evaluation graphic Battery systems substation Eiger

The battery systems were renewed cyclically during operation. The current status corresponds to the state of the art. Cleanliness and maintenance condition are excellent (see Figure 9-30).

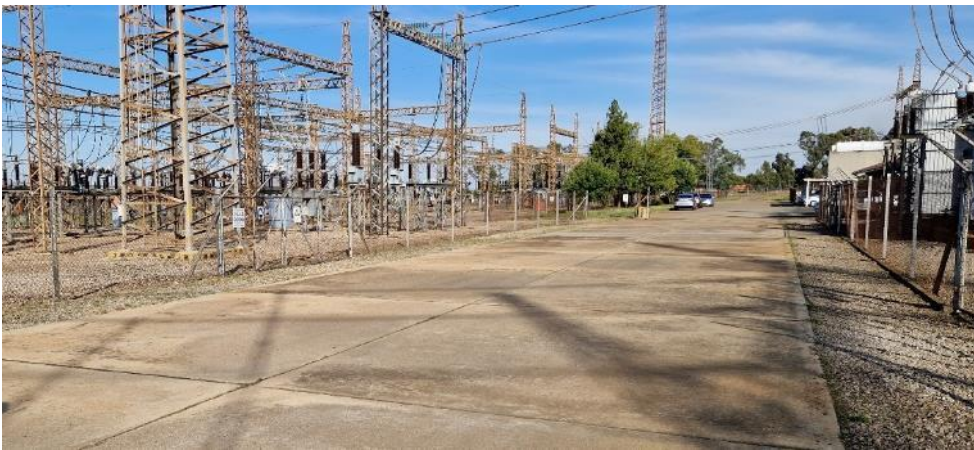
Figure 9-31: Street and fences substation Eiger

Activity class of streets, footpaths and fences classification 1,67 – Age-related wear and tear, but in a very good state of maintenance (see Figure 9-31).

- General condition AC classification 2 – Age-related wear and tear, no measures required.
- Fences and security AC classification 2 – Age-related wear and tear, no measures required.
- Dimensioning AC classification 1 – Age-related wear and tear, no measures required.

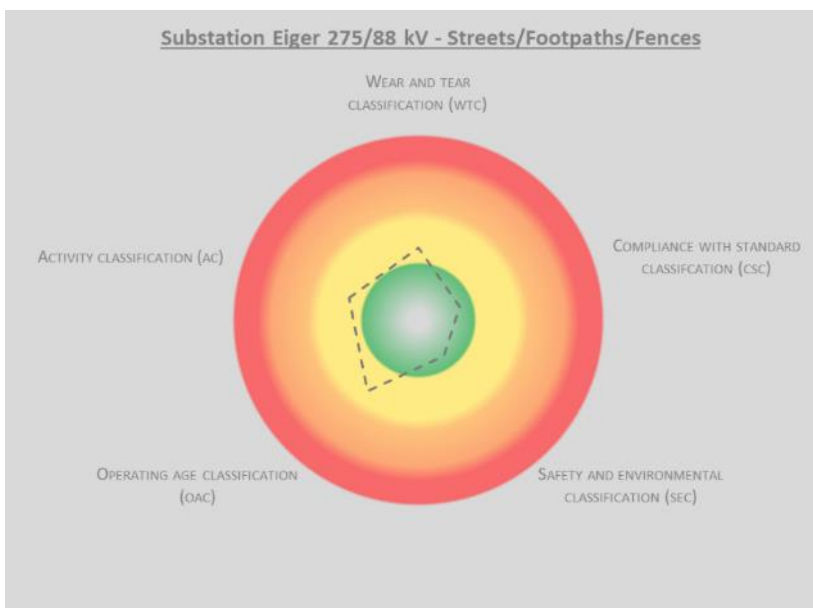
Figure 9-32: Evaluation graphic Streets/Footpaths/Fences substation Eiger

The streets, footpaths and fences are in good condition. No measures are required. Cleanliness and maintenance condition are excellent (see Figure 9-32).

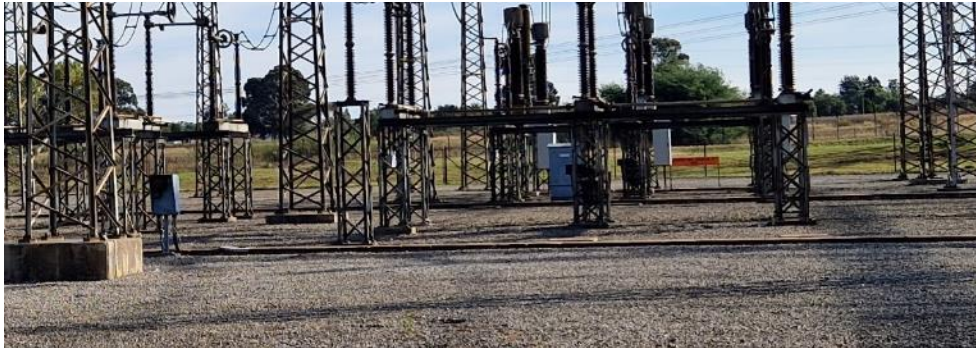
Figure 9-33: Example of Cable duct substation Eiger

Activity class of cable ducts classification 2 – Age-related wear and tear, but in a very good state of maintenance (see Figure 9-33).

- Ducts AC classification 2 – Age-related wear and tear, no measures required.
- Covers AC classification 2 – Age-related wear and tear, no measures required.
- General condition, weathering AC classification 2 – Age-related wear and tear, no measures required.

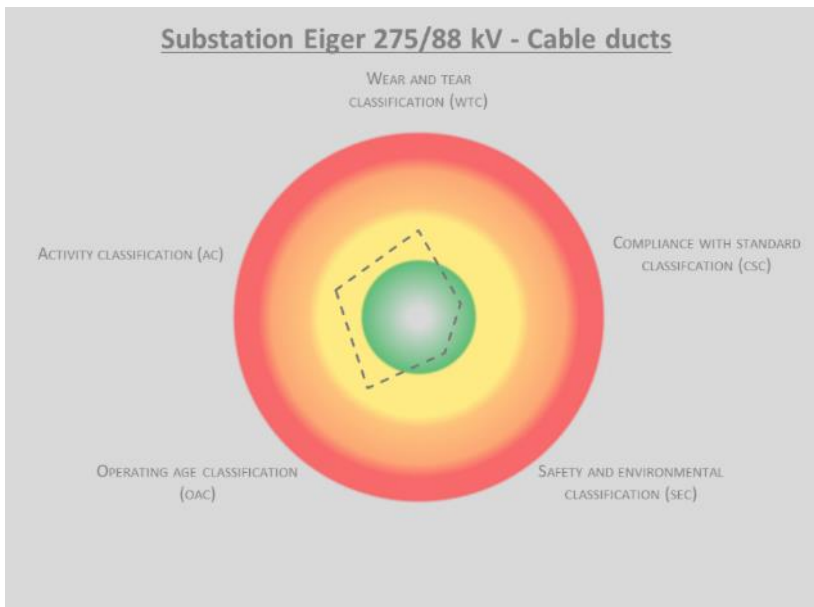
Figure 9-34: Evaluation graphic Cable ducts substation Eiger

The cable ducts are in good condition. No measures are required. Cleanliness and maintenance condition are excellent (see Figure 9-34).

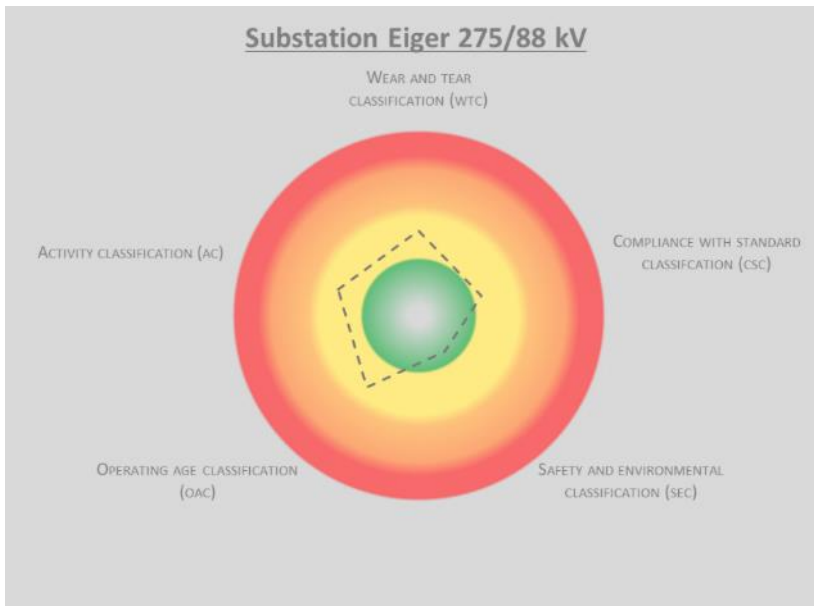
Figure 9-36: Evaluation graphic total substation Eiger

The Eiger substation was commissioned in 1973. During the years of operation, essential components such as all 3 power transformers, some circuit breakers, a few instrument transformers and disconnectors were gradually replaced. A general modernization measure was not carried out until now. A refurbishment project for the substation has been announced for the near future. Despite 50 years of operation, the substation is in relatively good condition (see for example Figure 9-35). This is due to the permanent renewal of worn components and excellent maintenance of all substation components. Accordingly, the substation can continue to operate safely for few years if the current strategy is continued by replacing worn parts and intensively maintaining all components. However, the already planned fundamental modernization measure for the substation should be carried out in the near future, as many of the components in operation have reached the end of their service life due to wear and tear and age.

The total evaluation results in an AC 1,95 for substation Eiger (see Figure 9-36).

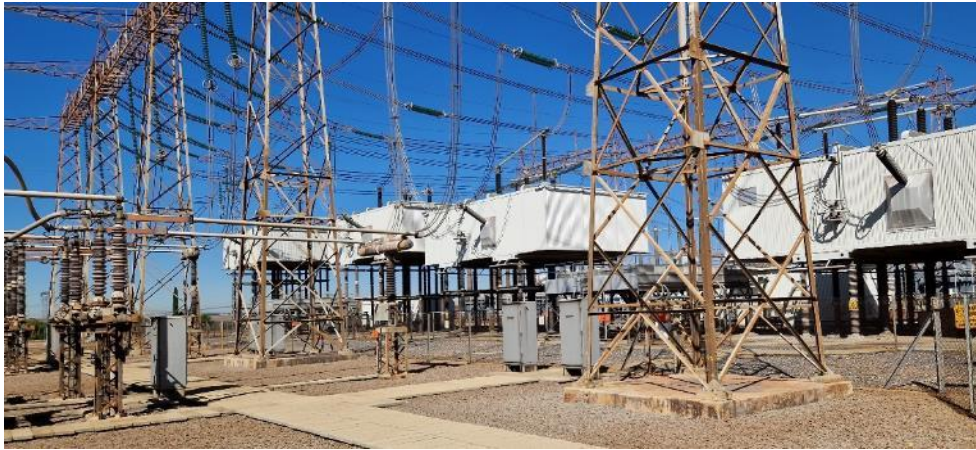
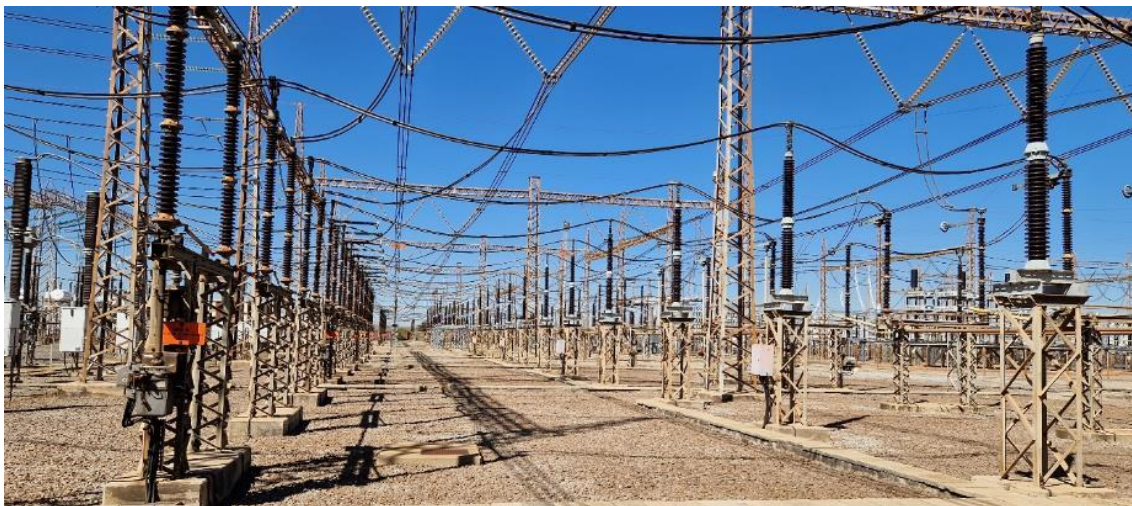
Activity class of converter bank and 275 kV switchgear classification 1,47 – small Wear and tear, no measures required (see Figure 9-38 and Figure 9-39).

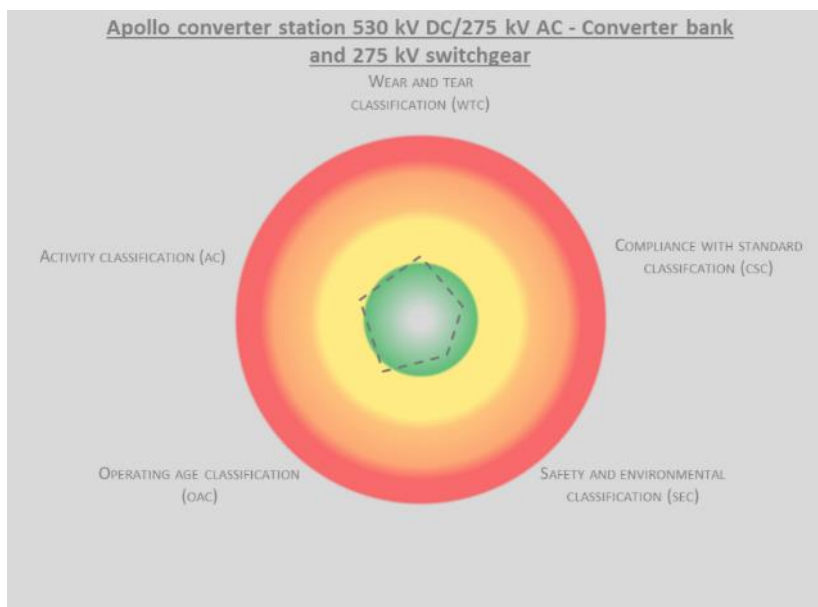
Figure 9-40: Evaluation graphic Converter bank and 275 kV switchgear Apollo Converter Station 530 kV DC/275 kV AC

All major components were replaced with new ones and the structural infrastructure was renovated from the ground up during the upgrading of the converter bank and the 275 kV

switchgear, which was carried out in 2013 to 2014. Cleanliness and maintenance condition are excellent (see Figure 9-40).

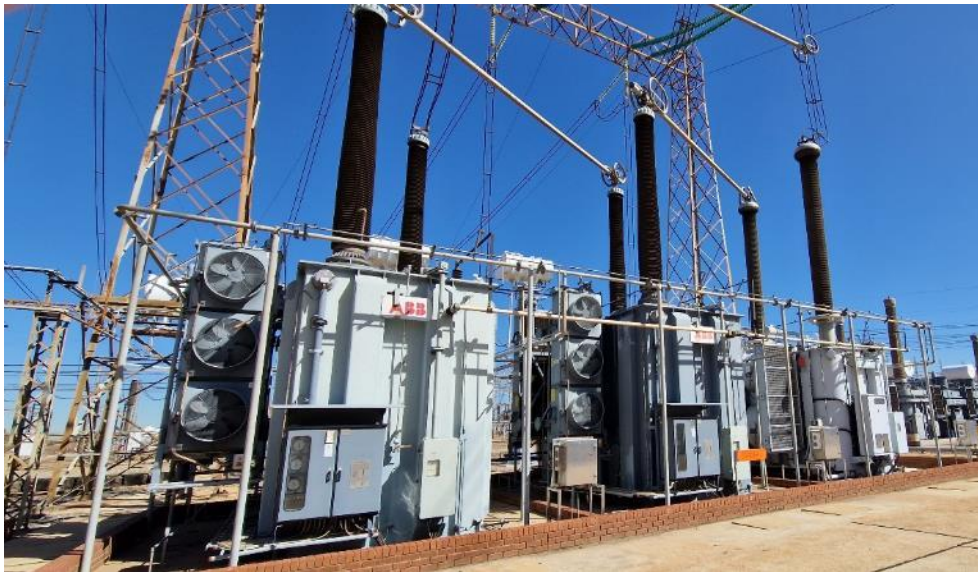
Figure 9-41 Transformers Apollo Converter Station 530 kV DC/275 kV AC

Activity class of Power Transformers classification 2 – The commissioning years of the 24 transformers used vary from 1977 to 2023. The tests of the gas-in-oil analyses also range from A very good, to E very poor. These results tend to deteriorate with the age of the transformers, but there are also some newer transformers with very poor test results. The transformers with class E test results must be monitored and replaced at short notice if possible (see Table 1). The majority of the transformers are in good overall condition (see Figure 9-41).
